SERVICE LIFE INVESTIGATIONS FOR AGING AIRCRAFT

Nesterenko G.I.

FATIGUE AND DAMAGE TOLERANCE OF AGING AIRCRAFT STRUCTURES

G.I.Nesterenko*

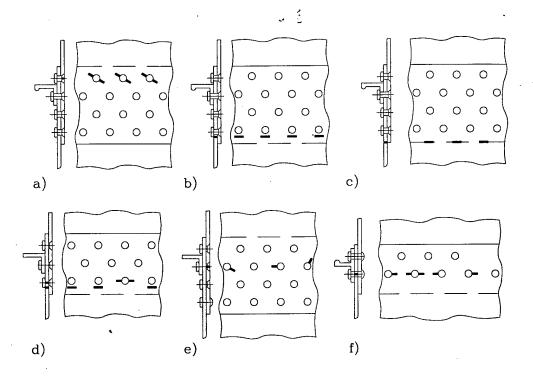
Test data analysis has shown that the residual strength of the structures with WFD is affected by numerous factors. In many thin sheets MSD appears on smooth surfaces rather than at holes as expected. References (2) and (3) demonstrate different WFD types revealed in airframes. Figure 1 presents MSD types detected in the riveted longitudinal splices of skin sheets in pressurized fuselages.

Figure 1 Multi-site skin damage of full-scale pressurized fuselages

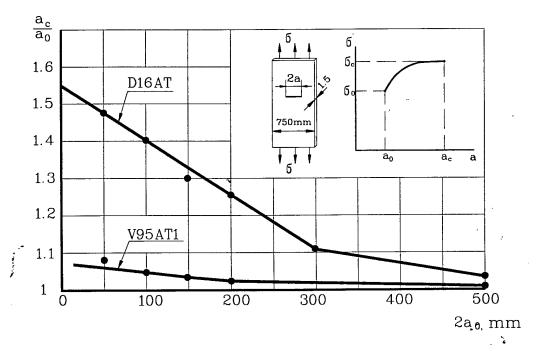
areas of primary elements due to hole and initial cracks. When calculating critical fracture stresses $\sigma_{fr.net}^c$, additional attention was paid to section weakening due to stable crack growth, see Fig. 2. The above mentioned stresses were compared to the yield strength $\sigma_{0.2}$. The stress intensity factor K_{fr} for final structure fracture has been calculated using approved methods. These factors were compared to plane strain fracture toughness $K_{\mbox{\scriptsize Ic}}$ or to apparent plane stress fracture toughness $K_{\mbox{\scriptsize app}}$ that was found in experiments on sheets with no bulging elimination devices.It follows from Table 1 that residual strength criteria for structures made of brittle materials like V95T1 and V93T1 are the linear fracture mechanics criteria $K_{fr} = K_{app}$ or $K_{fr} = K_{Ic}$. For many structures made of plastic materials like D16T and having WFD with interacting cracks the residual strength criterion may be formulated as follows: the stresses calculated stable crack growth are equal to yield considering $\sigma_{fr.\,net}^c = \sigma_{0.2}$. Some structures were broken when $\sigma_{fr.\,net}^c < \sigma_{0.2}$; this can be accounted for by the effect of local bending stresses difficult to evaluate. For a structure out of D16T alloy having several cracks in a single plane that have no interaction the residual strength criterion is, obviously, $K_{fr} = K_{app}$.

Figure 2 Stable crack growth from sheet cutouts

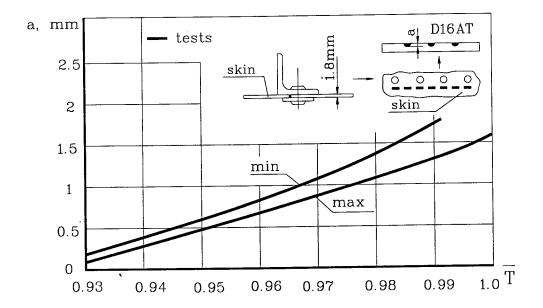
In Figs 3 through 6 the relative value of operational time T is the ratio of a current operational time to the time when the structure with WFD fails during the tests. Fleet data are reflected by the points presenting crack sizes and flight numbers of those airplanes where WFD was detected. These data have been the basis for crack growth duration curves corresponding to the probability P of 0.5, 0.05 and 0.001.

The analysis of data presented in Figs 3 through 6 and in Ref. (3) has shown that the ratio of crack growth time ΔT to the total life (equal to the time period before crack initiation, T_0 , plus crack growth duration) may range widely: $\Delta T/T_0 + \Delta T = 0.03 - 0.8$. It also follows from the analysis that defining inspection intervals for structures with likely WFD should be based on safety factors of 2 to 3, as related to the mean values of in-service multi-site crack growth duration.

Figure 3 Relative MSD growth time: horizontal panel of pressurized fuselage

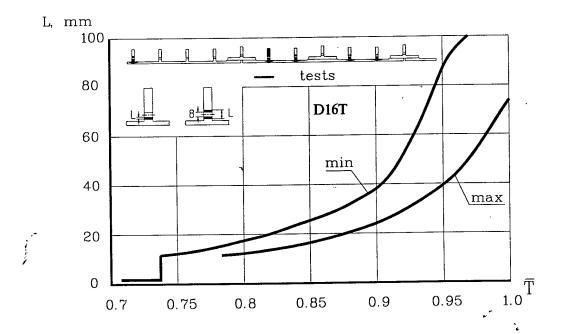
Figure 4 Relative MED growth evolution time: wing panels

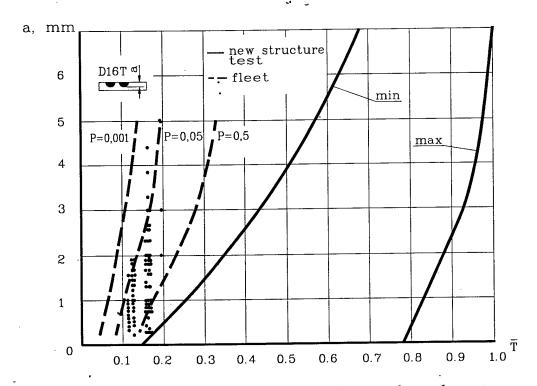
The most important test data on fatigue crack growth duration for full-scale airplane structures with WFD are presented in Ref. (3). Figures 3, 4, 5 and 6 provide additional test data. Figures 5 and 6 compare these data with the in-service crack growth data. A fractography methodology was developed, and crack growth curves on the basis of structural tests were generated, by Stoyda and Yekimenkov (5). A methodology for analysing the cracks detected in the course of aircraft inspection was developed by Senik (6); it is based on mathematical statistics; also, in-service crack growth curves have been generated.

Figure 5 Relative MSD growth time: upper wing panel attachments

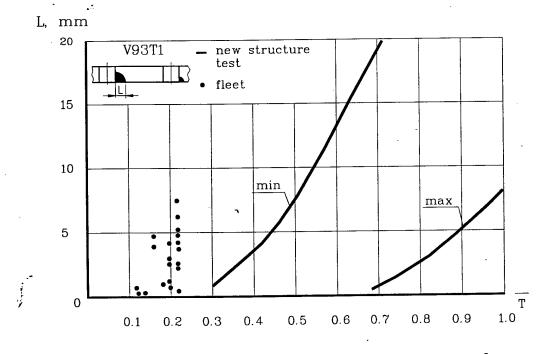
Figure 6 Relative MSD growth time: lower wing panel attachments

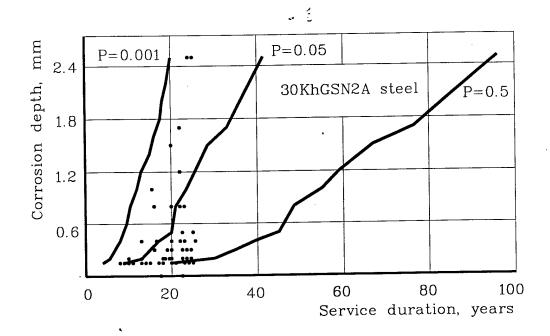
Figures 7 through 10 present the data on in-service corrosion damage growth. These data are utilized to prescribe inspection and repair intervals for relevant structures.

Figure 7 Corrosion propagation in engine frame strut

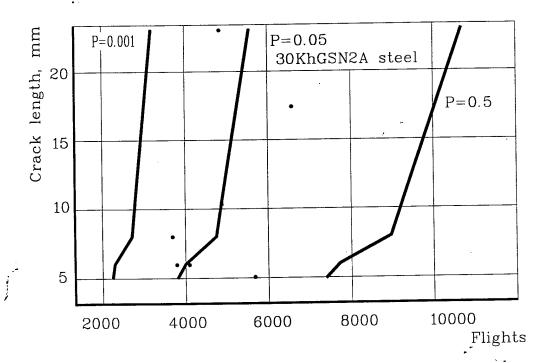
Figure 8 Corrosion-fatigue damage growth in landing gear cylinder

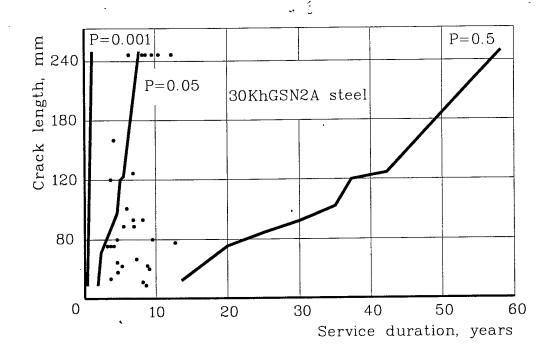
Figure 9 Stress corrosion development: landing gear unit

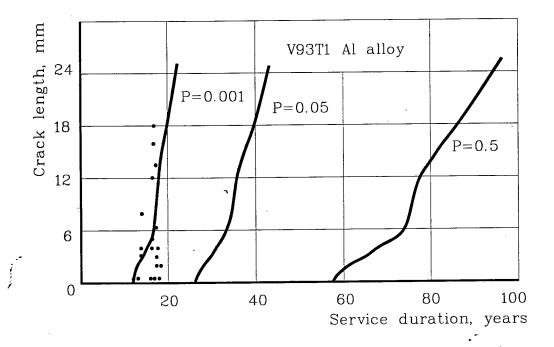
Figure 10 Stress corrosion development: flap attachment bracket
